HFBR Characterization

- 2001: Characterization of the HFBR, including reactor, systems, structures, support buildings, and soils
 - Determine current state of the facility in preparation for stabilization and future decommissioning
- 2004 2005: Characterization of additional areas
 - Fill in gaps in the previous characterization and estimate the amount of radioactivity present at the HFBR

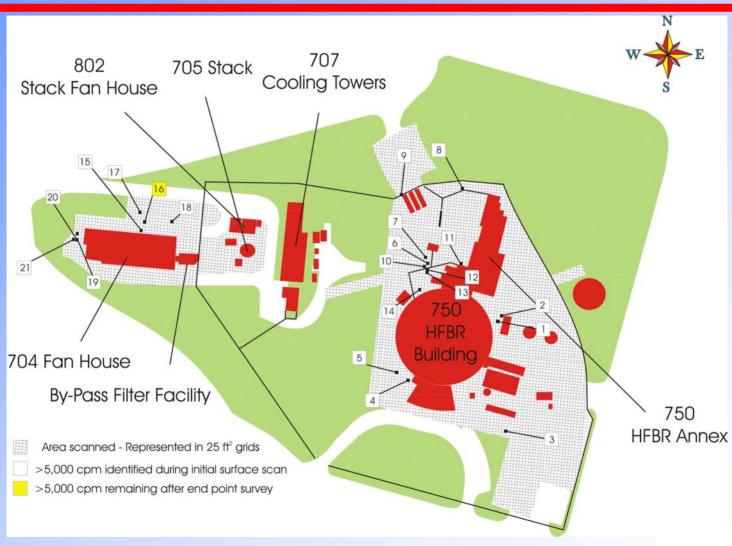
HFBR Walkover Survey

- Performed comprehensive gamma survey
 - Majority of area determined clean
 - Less than 0.3% of the 6,640 twenty-five ft² grids had findings >5,000 cpm above background threshold
- Positive findings
 - Isolated in size, mostly particles, and extent
 - Attributable to past practices
 - Not attributable to chronic leaks, releases, etc.
- 21 findings total
 - All but one cleaned up as part of survey
